The rogues' gallery

Bill Wright draws inspiration from some of the classic cock-ups he's seen and corrected in a lifetime of aerial rigging

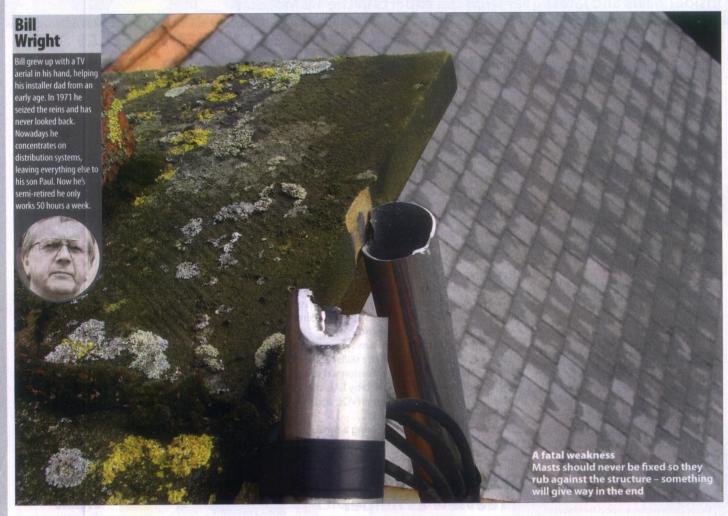
A fatal weakness

Any aerial mast will bend slightly in the wind and the degree of movement should be considered when the mast is positioned.

Masts should never be fixed so that they are pressed against masonry or guttering. That is what's happened here – with the inevitable result. The four vertically polarised cheap-as-chips aerials are like a sail in the wind, so after a short time the mast has rubbed against the abrasive masonry enough to be fatally weakened.

To make matters worse, there were four cheap aerials on one mast – and

on the whole block of flats there were four installations like this – one on each chimney! Sixteen cheap aerials instead of one good aerial and an amplifier.

Where the chimney has a large decorative corbel, the options are either to find a bracket with sufficient standoff or, if the owner agrees, chip away an inch or so of the overhanging masonry.

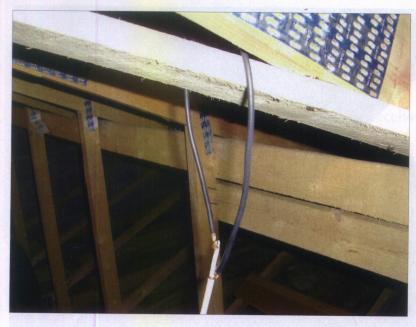
Two aerials, one cable

Two into one Extra cables should be attached via a junction box, not to the aerial itself

It's only after Roy's taken the money and scarpered that the customer tries the living room TV set and finds that reception is degraded. When a second downlead is needed the first job must be to measure the signal to make sure that it will withstand the extra losses.

recommended. Connecting two cables directly to the terminals affects the aerial's performance and creates an impedance mismatch. The hole isn't sealed either, so soon the air space in both cables will fill with water. Note also the lack of a balun on this cheap contract aerial.

Then a proper outdoor splitter should be used. Punching a hole in the junction box cover and shoving the second cable through it is definitely not

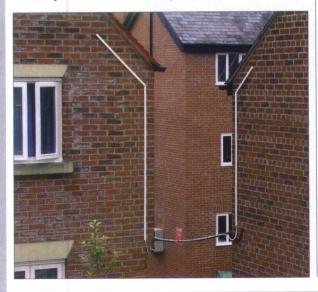
Lazy linking

(below) Trunk call **Ugly white** trunking and cable on a sloppy outdoor job

This is just hideous isn't it? In order to get a cable from one loft to the next someone has put all this mini-trunking on the walls.

It was obviously done like this to 'hitch a ride' on an existing catenary wire - but it would have been much better to have put a neat catenary across between the cable entry points at the top.

White cable shouldn't be used outdoors because the plastic perishes in sunlight and it looks awful, and just highlights the bad workmanship here. I wonder how the mini-trunking is fixed to the wall. Couldn't be the adhesive type, surely?
